# Manhole Inspection Summary

Manhole # S39A\_\_043MH

Insp Date: **12/5/07 10:01 AM**

**Location** Address: **old towne mall parking lot**

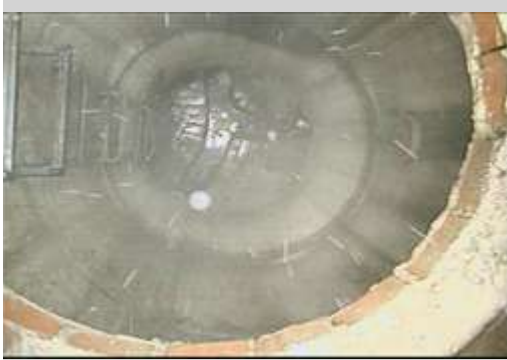
Miscellaneous

Top View with drop@3 visible

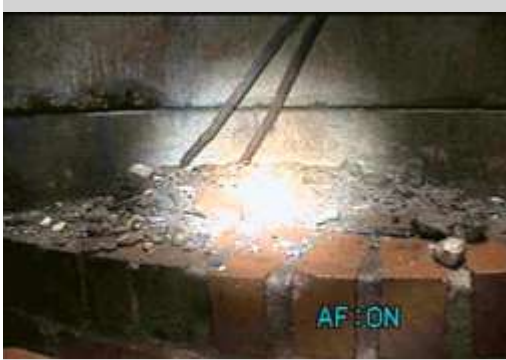
Miscellaneous

Condition: ☒ Sound ☐ Cracked ☐ Root Intrusion ☐ Deteriorated ☐ Leaks ☐ Debris

bench debris

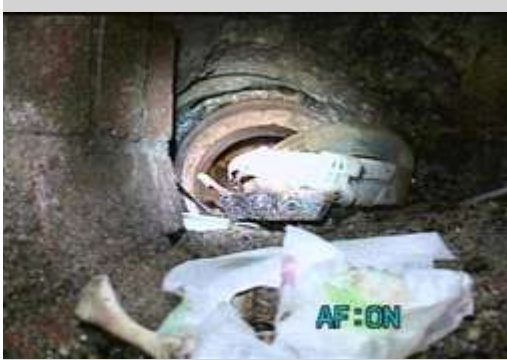
Miscellaneous

channel debris

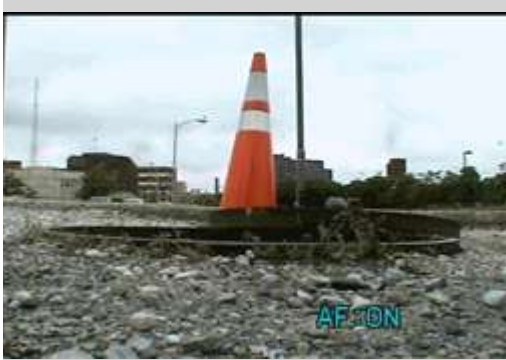
Miscellaneous

Diameter: **32** (in.) Length: **0** (in.) Dist A/B Grade: **1** (in.)

cover above grade

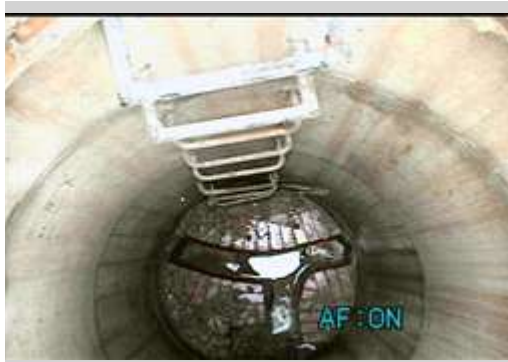
Defect 5

Count: **9** Missing: **0** ☒ **Corroded**

corr steps

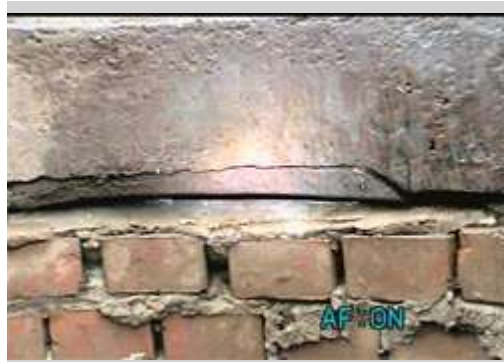
Defect 4

Condition: ☐ Sound ☒ **Cracked** ☐ Leaks

Condition: ☐ Sound ☒ **Cracked** ☐ Root Intrusion ☒ **Loose Brick** ☐ Deteriorated

cracked frame; loose bricks in chimney

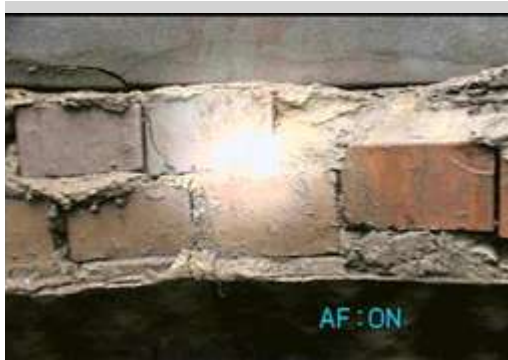
Defect 3

chimney bricks are cracked

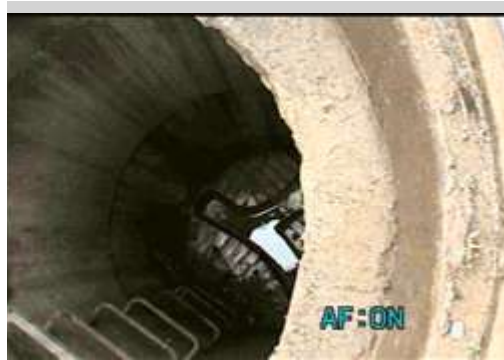
Defect 2

Offset: **3** (in.)

frame offset

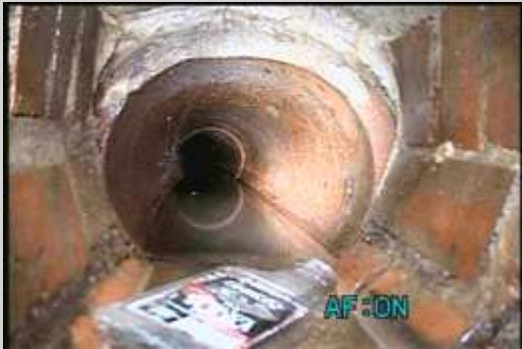
12 O'Clock Outflow

Pipe Height: **0** (in.) Direct  
Pipe Material: **Clay** ☐ Pipe Lined  
Invert Depth: **12.25** (ft.) Flow Characteristics: **Slow**  
Deposits: ☐ None ☐ Mud ☐ Sludge ☒ **Debris** ☐ Grease  
Silt Depth: **1** (in.) Deposits Extent: **Light**  
Infiltration: **None** Pipe Seal Cond: **Unknown**

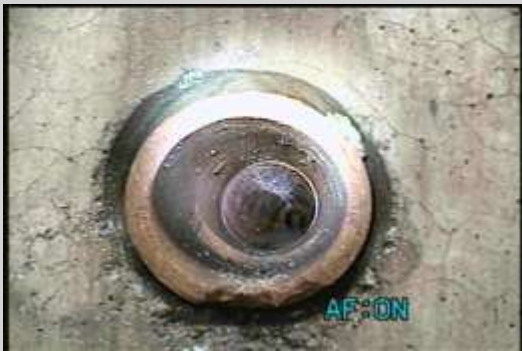
3 O'Clock Inflow

Pipe Height: **0** (in.) Direct  
Pipe Material: **Clay** ☐ Pipe Lined  
Invert Depth: **5.83** (ft.) Flow Characteristics: **Slow**  
Deposits: ☐ None ☐ Mud ☐ Sludge ☒ **Debris** ☐ Grease  
Silt Depth: **1** (in.) Deposits Extent: **Light**  
Infiltration: **None** Pipe Seal Cond: **Unknown**

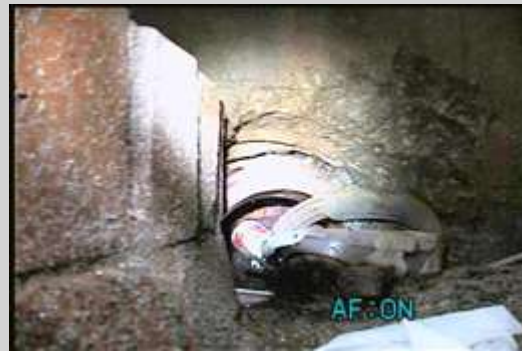
Drop In @ 3 OClock

Drop: **Outside Direct**  
Angled: Reading: **0.00** (ft.)  
Inv Depth: **11.90** (ft.)  
Drop Condition: **Open**

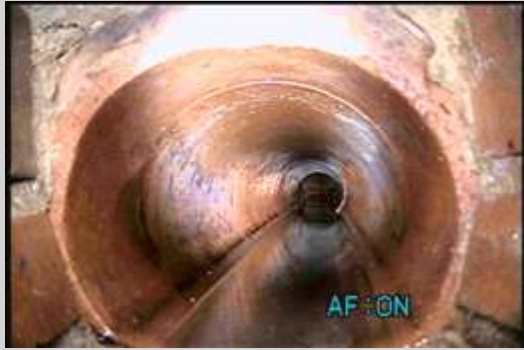
7 O'Clock Inflow

Invert Depth: 12.00 (ft.) Flow Characteristics: **Slow**

Deposits: ☐ None ☐ Mud ☐ Sludge ☒ **Debris** ☐ Grease

Silt Depth: 1 (in.) Deposits Extent: **Light**
